# **Assessing Slope Stability at Seroe Mansinga and Caracas Bay, Curacao**

**Final Report for APNA, Willemstadt, Curacao**

**The University of Texas at Austin  
Jackson School of Geosciences  
Tuesday, February 5th, 2008**

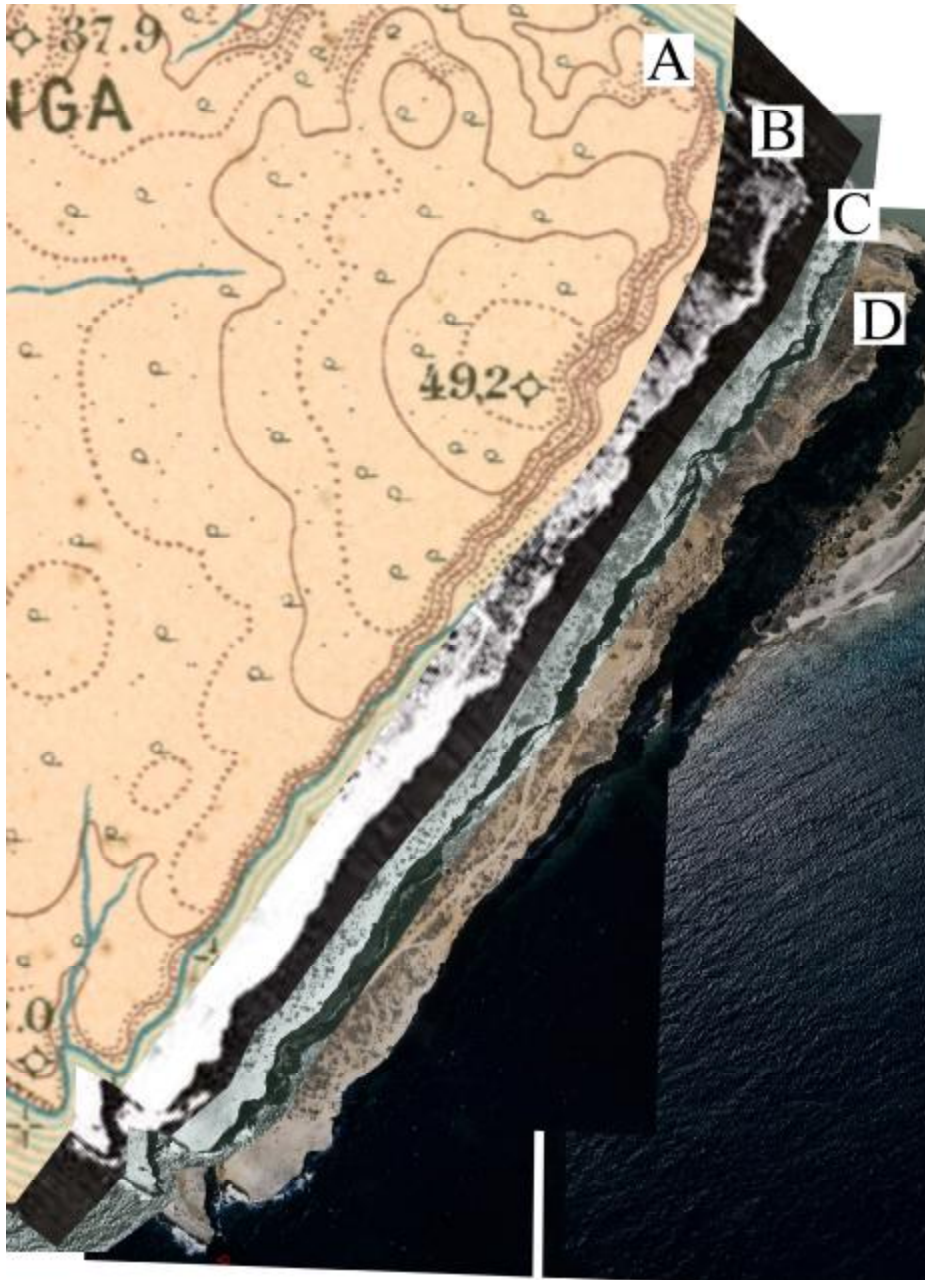
**Figure 3.** Comparison of the position of the cliff face along the western edge of Caracas Bay at four times over the past century: 1906, sometime in the 1960's, 1989, and 1998. The positions of the coastlines at the four time are staggered to show similarities and are not in a geographic context. Note that the the position and overall shape of the cliff face has remained relatively unchanged since the first topographic survey of Curacao by Werbata in 1906. Mass wasting of the cliff face is a potential problem especially in the area marked by the red line on the map in Figure 1 because of the fractured and cavernous, massive

*limestone as shown in Figure 2 and the existence of large open fissures aligned parallel to the cliff face as shown in Figure 3.*

*A = Werbata (1906)*

*C = KLM AeroCarto (1989)*

*D = Curacao - DOW (1998)*

Close inspection of these maps shows that the rate of mass wasting along the cliff face over the past century has not been significant in the period of 1906 to 1998. However, the presence of the fissures at the top of the cliff indicate the possibility that sudden mass wasting events could occur that are triggered by earthquakes or heavy rainfall events.

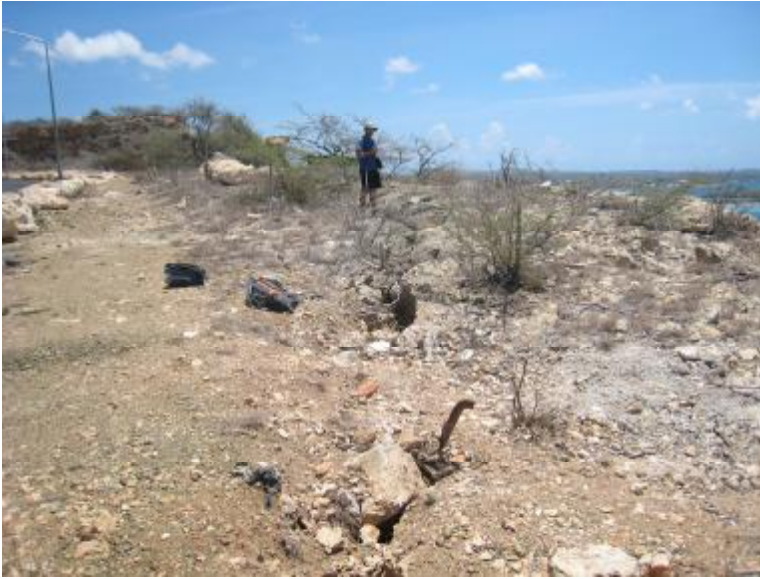
**Figure 4.** *Photo taken at the top of the cliff face looking north along the western edge of Caracas Bay showing large fissure that has formed parallel and about 5 meters landward of the vertical cliff face. Note that the road along the eastern edge of the APNA development is visible to left of the photo. The fissure runs from the viewer to the person in middle distance and extends as an open crack several meters downward into the fractured and cavernous massive limestone beneath the surface. The fissure remains open despite efforts to fill in the fissure with soil, rocks, scrap metal, and other debris. Large boulders at the base of the cliff in this area attest to previous, sudden mass wasting events of limestone boulders along the cliff face. Based on the maps shown in Figure 3, the locations of these sudden mass wasting events are not detectable from 1906 to 1998.*

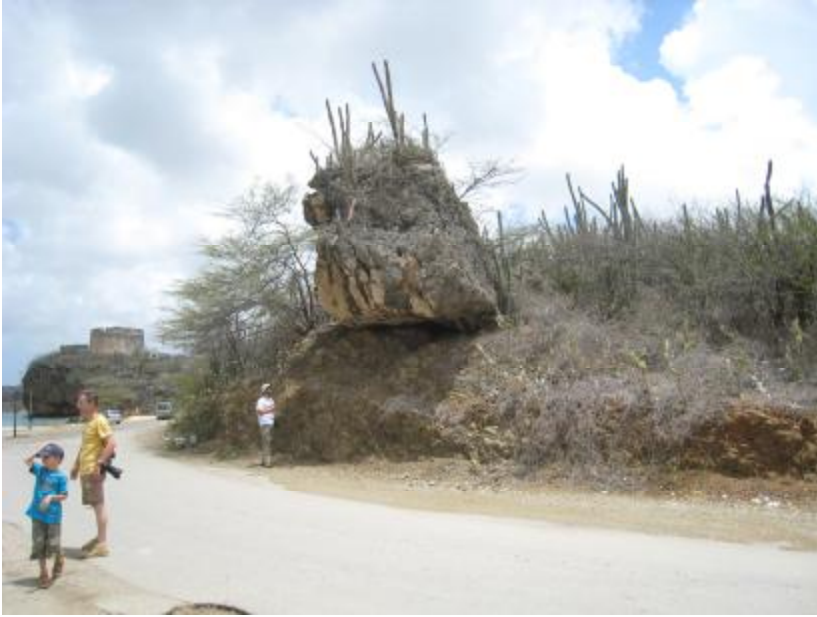
**Figure 5.** Photo looking northward of a large limestone boulder of the Seroe Domi Formation directly overlying Cretaceous basalt near Fort Beekenburg on the Caracas Bay peninsula east of Caracas Bay. The limestone block dips gently about 10 degrees towards the viewer. Following DeBuissonje and Zonneveld (1976) we interpret this block and surrounding limestone blocks of comparable or larger size as slide blocks along the top of a gently seaward upper surface of basalt. Dips in the limestone strata in the distance near Fort Beekenburg are highly variable (note dip in that area is more to the right or to the east – cf. map in Figure xx) and suggest that a larger limestone block may have slid along the top of the basalt layer in the Fort Beekenburg area.

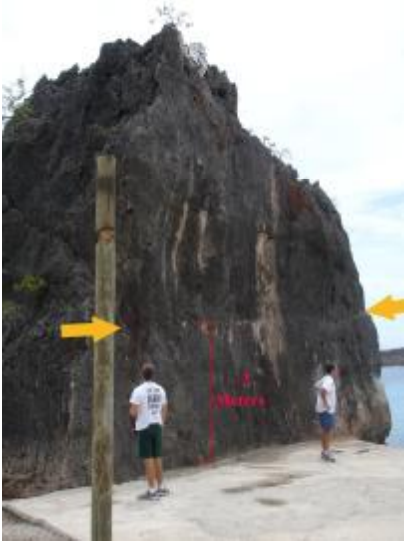
*Figure 6. View of early Holocene notch indicated by yellow arrows about 3 meters above sea level next to pier at east side of Caracas Bay. The notch is carved in a large block that we infer was created during the catastrophic Caracas Bay slide about 14 ka. Eustatic sea level studies indicate that the notch is about 6 ka. The horizontal nature of the notch indicates that the block has not moved over the past 6 ka.*

**vi. Geological Controls on Slide Timing: the Holocene notch.** Sea-level studies have shown that approximately 6000 years ago, Global sea level was between 2 and 4 meters higher than what we observe today. Evidence for the 6000 year old sea level high-stand is sometimes preserved as a horizontal erosional feature in limestone (bio-erosion often occurs where the surf hits the shore) (see Figure 6, 7). The previous sea level high stand can also be determined from the height of coral reef platforms that grew during this period (see Figure 8). This erosional line is often referred to as the “Holocene notch” (See figure 6).

By noting where this notch does and does not exist along Seroe Mansinga and Caracas Bay, we can estimate what features along the shore line were in place 6000 years ago and what features are younger than 6000 years. The existence of the Holocene notch at shoreline boulders adjacent to Ft. Beekenburg (figure 6, 7) clearly indicates these boulders have been in place for at least 6000 years. These boulders are considered part of the upper-terrace limestone formations on Curacao, and therefore, and are not oriented in their original upright position. They were likely placed in their current position during the major slide event that formed Caracas Bay. The fact that we can trace a Holocene notch across these rocks therefore indicates that the slide that emplaced the rocks occurred at least 6000 years ago.

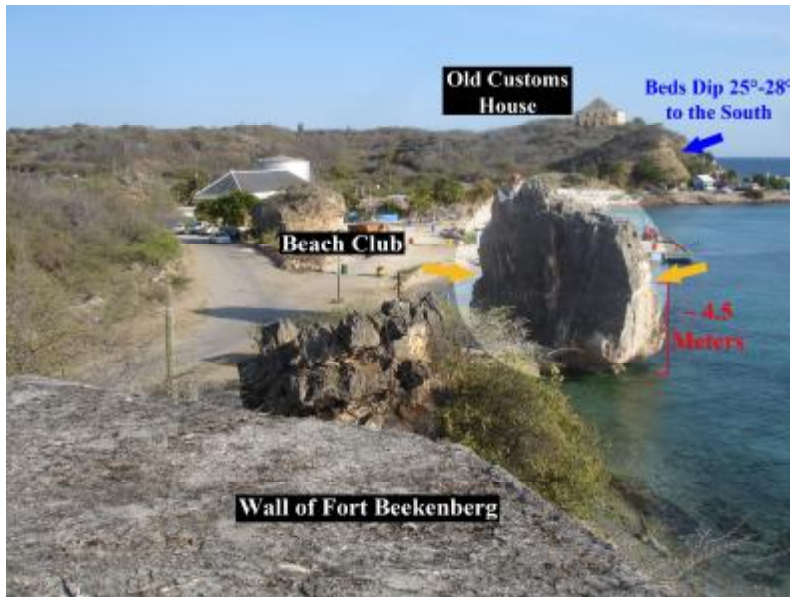
*Figure 7. View of early Holocene notch indicated by yellow arrows about 3-4.5 meters above sea level south of Fort Beekenberg on the east side of Caracas Bay. The notch is carved a large block highlighted in the circle that we infer was created during the catastrophic Caracas Bay slide about 14 ka. Eustatic sea level studies indicate that the notch is about 6 ka. The horizontal nature of the notch indicates that the block has not moved over the past 6 ka. The area of the beach club marks the southern extent of the debris field formed by the large limestone blocks. To the left of the area marked Beach Club, limestone blocks can be observed sitting directly on Cretaceous basalt. To the south beneath the hill of the Old Customs House, the rocks consist of Miocene sedimentary rocks dipping 25-28 degrees to the south.*

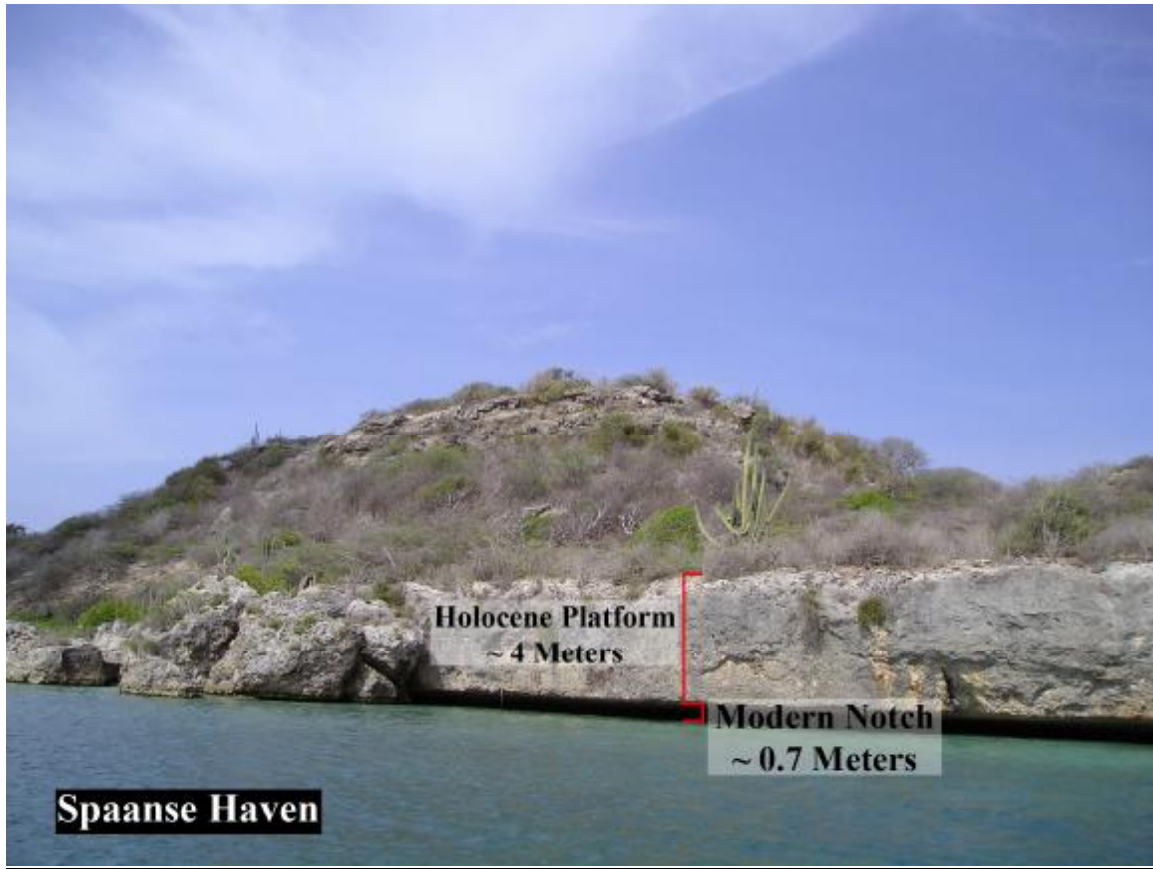
*Figure 8. View of early Holocene platform indicated by red bar about 3-4 meters above sea level on the south side of Spanish Water (Spaanse Haven). Note the presence of the modern sea level notch less than 1 meter above sea level. The top of this platform would correlate with the early Holocene notches shown in Figures A.1 and A.2 and indicates the stability of this area for a period of 6 ka.*

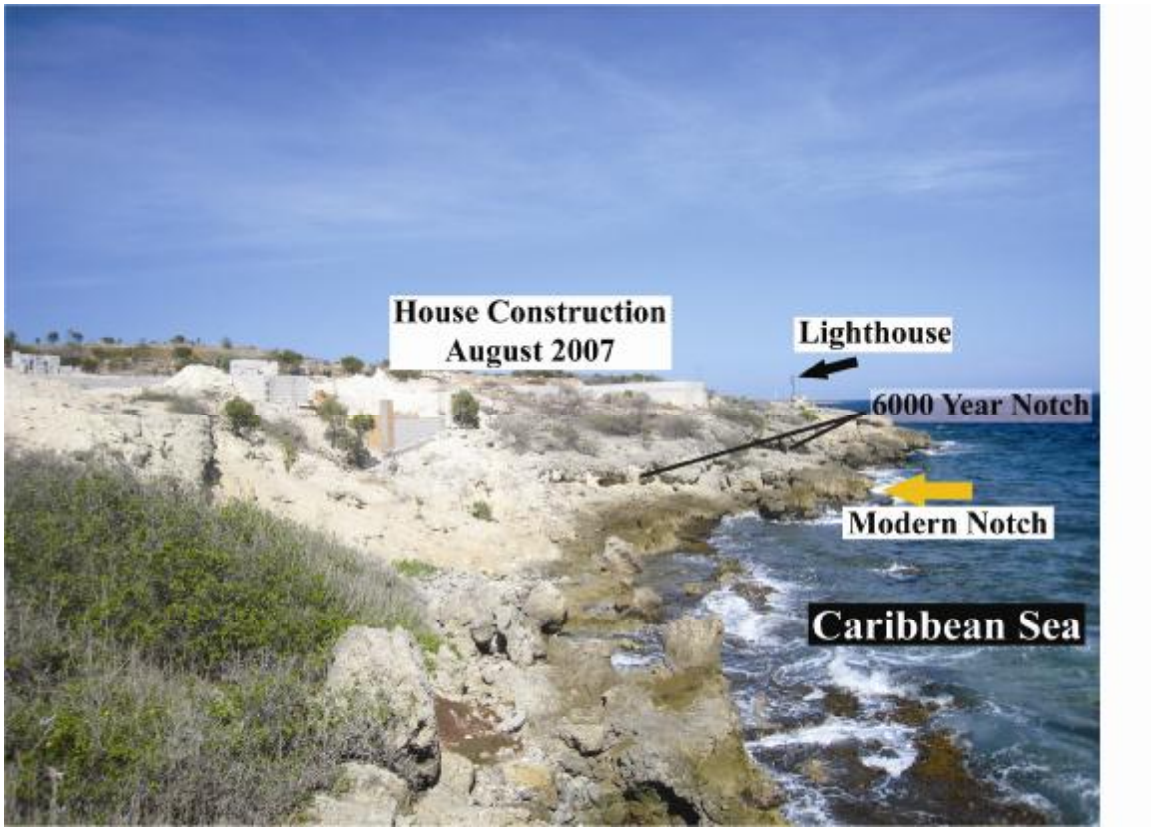
*Figure 9. View of Holocene (6000 year old) notch, approximately 2-4 meters above sealevel, above the current modern notch, along the south side of the APNA property. Evidence for a nearly continuous notch along the south shore indicated that this shore line has remained stable, and that the south shore has not undergone any significant erosion for at least 6000 years. This is not true along the Seroe Mansinga Cliff, where no clear or continuous Holocene notch is observed.*

The Holocene notch was also found along nearly all of the south shore (see figure 9) of the APNA property, indicating that this region has experienced little erosion for at least the past 6000 years. The one region on the property that we could not find a clear Holocene notch, however, was the cliff face along Seroe Mansinga. The fact that the notch exists elsewhere in Caracas Bay, but not at the cliff face gives credence to the idea that one major event formed the bay more than 6000 years ago, but since then, smaller-

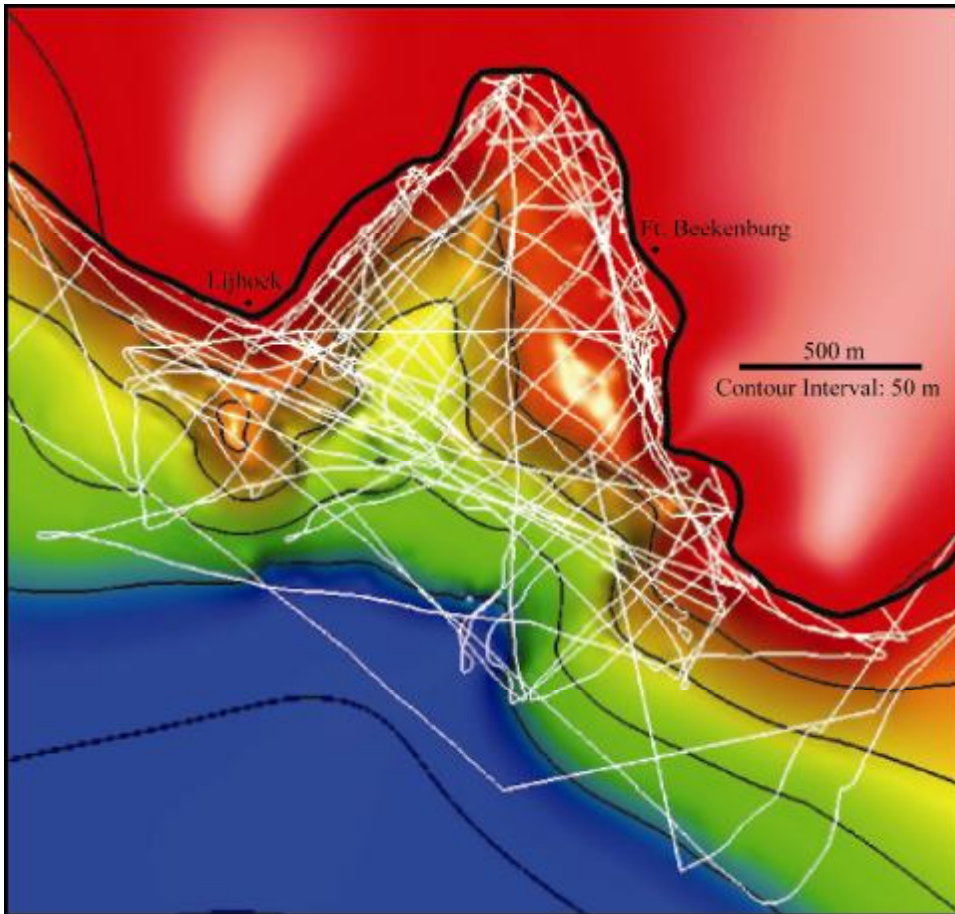
**Figure 10.** Map view showing the location of seismic lines (white) collected in Caracas Bay and along the southern edge of the Seroe Mansinga property. The bathymetry and contours projected on the image were created by merging and interpolating the 2D seismic lines into a 3D image.

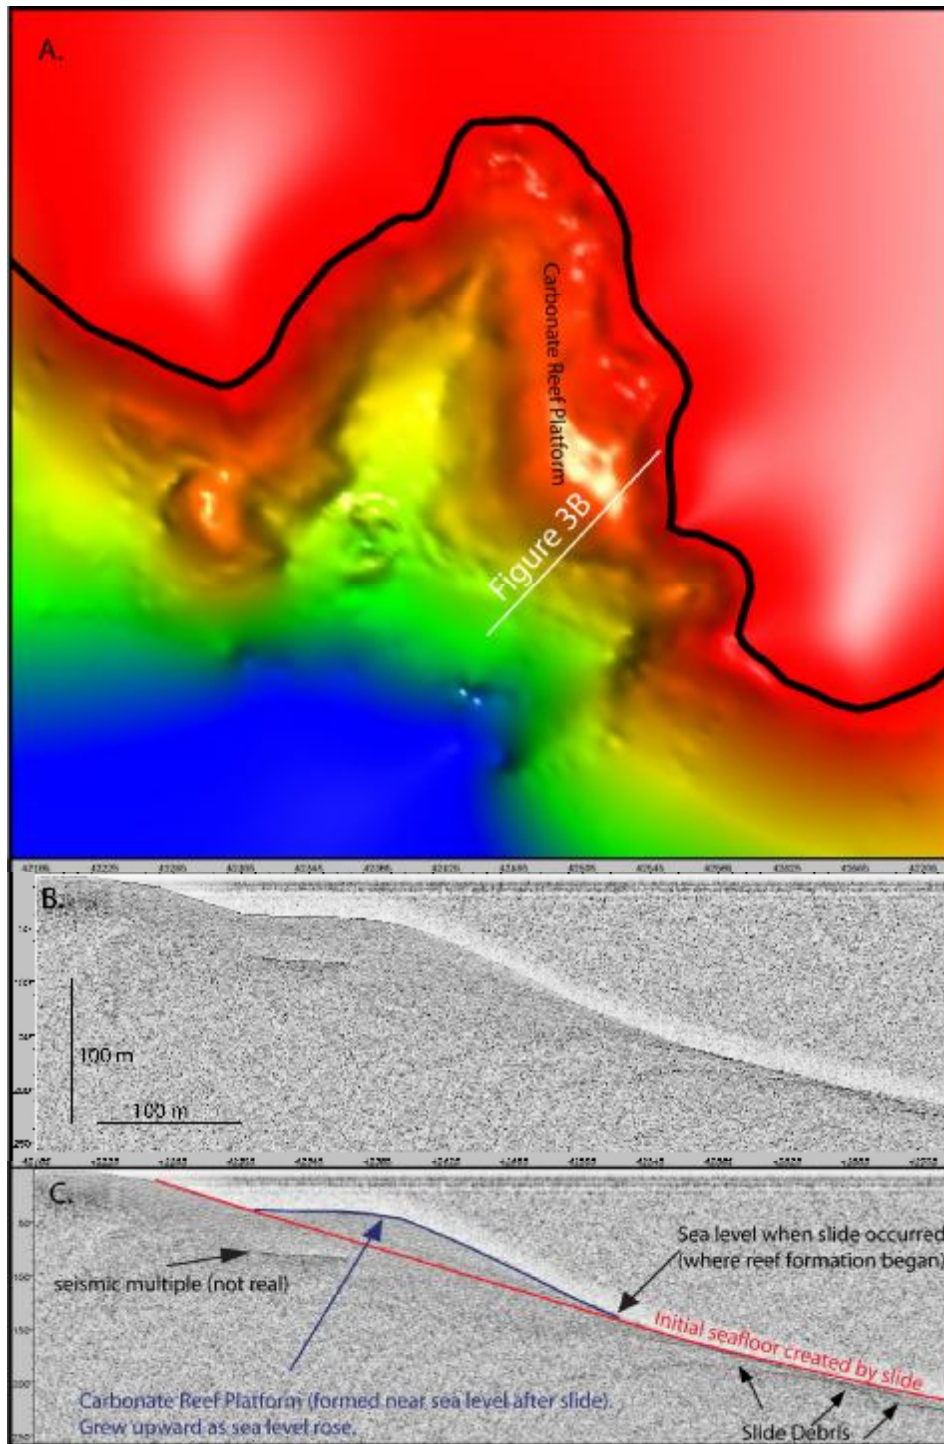
**Figure 12.** (A) Map view of Caracas Bay and the location of the seismic line (white line) shown in Figure 12B and C. (B) Uninterpreted seismic line that starts near the LNG pier at Caracas Bay (left side) and ends ~700 m to the south (right side of line). (C) Geologic interpretation of this seismic line. The red line indicates the original slope of the seafloor, created by the slide, and the purple indicates the location of the carbonate reef. Note that where the carbonate reef ends down slope, slide debris material begins, suggesting that the carbonate reef formation masks the original seafloor structure created by the slide. The carbonate reef platform, however, is significantly smaller in size -or non-existent - along much of the western side of Caracas Bay.

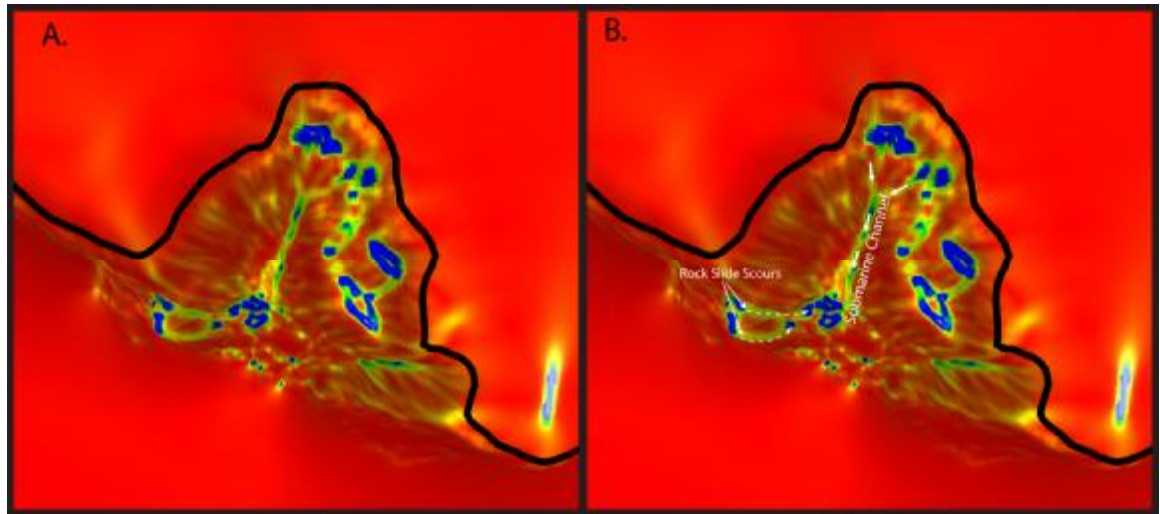
Figure 14. Change in Azimuth-dip angle generated from seismic data, showing the location where concavity/inflection points occur. (A) is uninterpreted, (B) is interpreted. Note the clear evidence for submarine stream bed, which was likely exposed immediately following the slide event, when sea level was much lower. The image also shows some evidence for scour marks from smaller submarine mass-wasting events occurring southeast of the lighthouse. Debris can be seen south of the channel and larger, broader reef-mounds exist in the north and eastern part of the bay.

By recognizing that the slide occurred when sea-level was 50-100 m lower (the depth where the reef first began forming), we can estimate the approximate age of the slide event. Previous coral studies (such as Siddall et al., *Nature* 2003) reveal that sea-level has been on average steadily rising over the past 20,000 years. Using modeled sea level curves and seismic data, we estimate that the base of the carbonate platforms (that initially formed immediately following the slide event) are located at water depth of ~50-100m in Caracas Bay (figure 12). From coral dating studies, we know that sea level was 50 m lower ~11,000 years ago, and 100 m lower about ~15,000 years ago. Taking our best estimate that reef formation occurred when sea-level was ~85 m lower, the slide occurred approximately ~14,000 years ago. Therefore, we estimate that the age of the main slide event that formed Caracas Bay is ~14,000 years (+/- 2000 years) (figure 13). As noted above, the carbonate reef platform is relatively intact everywhere, except along parts of the shoreline adjacent to Seroe Mansinga, the western side of Caracas Bay. The lack of a well defined carbonate platform in this location and the evidence from seismic data for slide blocks both below and down slope of this region strongly suggests that ongoing smaller scale mass-wasting has periodically occurred since during the past 14,000 years, after the initial slide occurred (figure 14) .

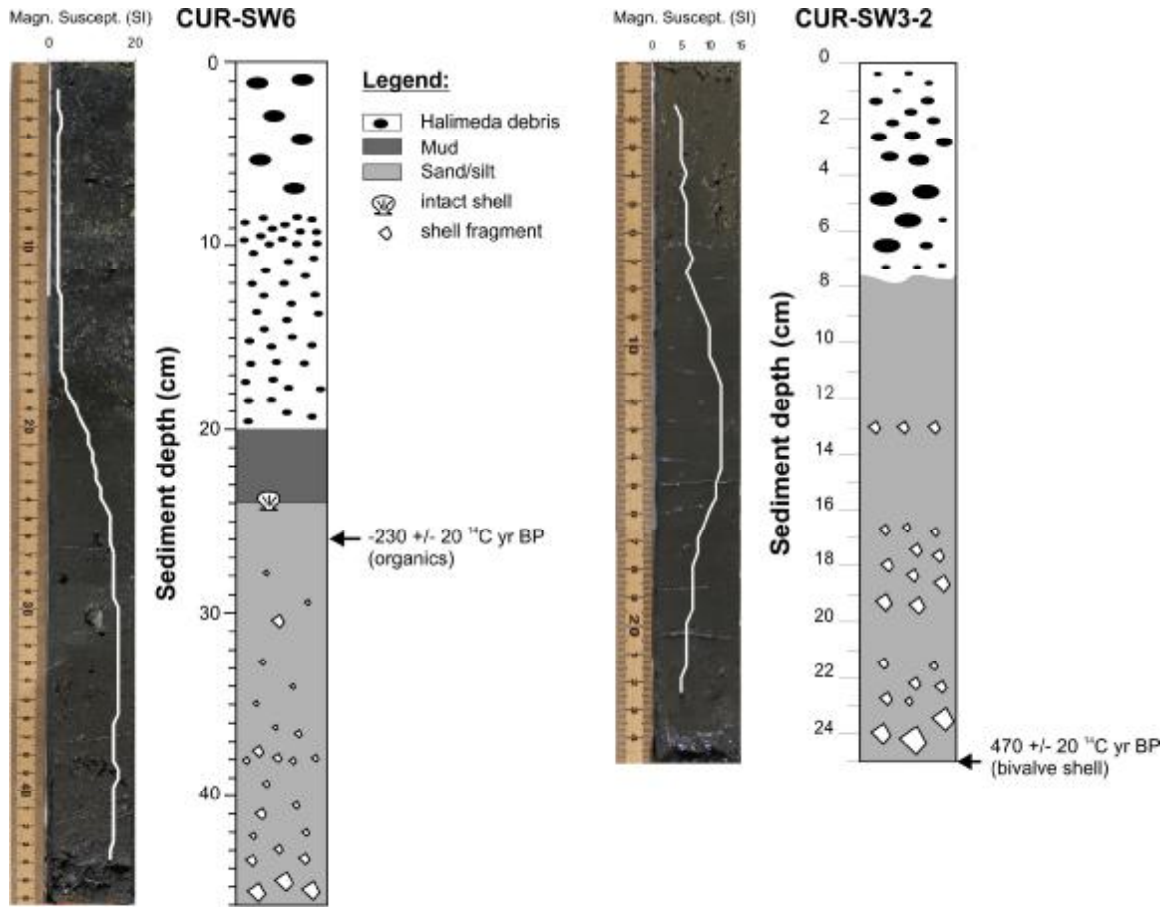
**Figure 2-2:** Core photos and schematic profiles of cores SW6 and SW3-2 (Spanish Water Bay).

Halimeda debris layer. SW6 radiocarbon dating used organic matter from 26cm sediment depth and indicated a younger than AD1950 deposition of retrieved sediments (Fig. 2-2, Table 2-4).

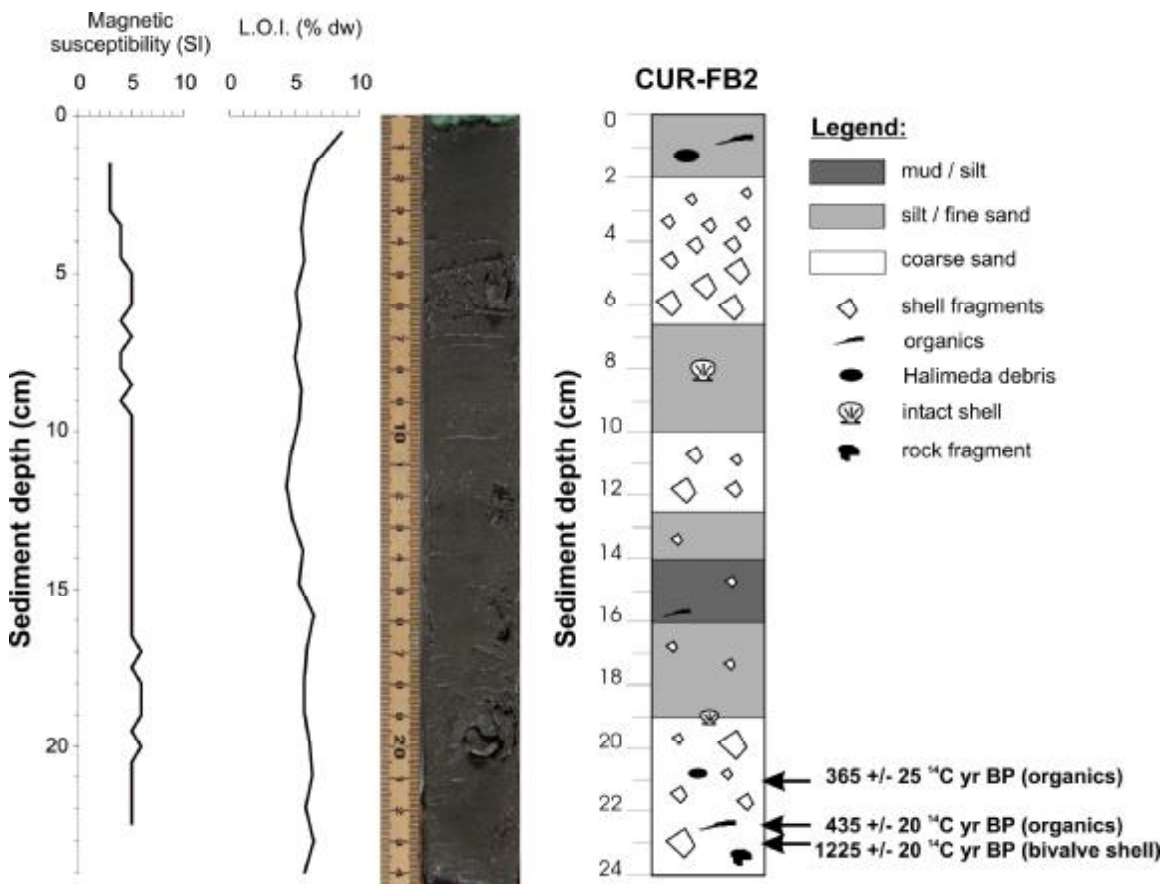
**Figure 2-4:** Core photos and schematic profiles of core FB2 (Fuik Bay).

Two sediment cores 20cm and 24cm long were recovered from the southeastern inlet channel of Fuik Bay. The water depth was 2m. The coring site was surrounded by mangroves. The cores are identical in their lithology. Both are slightly laminated and normal graded, with coarse sand at the bottom fining upwards into silt. Core FB2 contains three sandy layers of bivalve and gastropod shell fragments, minor terrestrial organic matter and Halimeda fragments in 2-6.5cm, 10-12.5cm and 19-24cm depth (Fig. 2-4). Scattered large broken and rarely intact shells of *Chione cancellata* (Cross-barred Venus), *Tellina sybaritica* (Dall's Dwarf Tellin), *Cerithiopsis emersoni* (Awl Miniature Cerith) and older reef Oyster shells occur in all of these layers (Table 2-2, Table 2-3). Basaltic rock fragments and plant remains are concentrated in the lower section of the core. Microscope analysis showed many marine microfossils like marine gastropods and foraminifera (*Globorotalia*) throughout the core. Three ages from a bivalve shell of *Tellina sybaritica* from 23cm core depth and terrestrial organic matter from 21cm and 22.5cm depth reveal ages of  $1225 \pm 20$  <sup>14</sup>C yr BP,  $365 \pm 25$  <sup>14</sup>C yr BP and  $435 \pm 20$  <sup>14</sup>C yr BP, respectively (Table 2-4). Calibration of ages of terrestrial plants indicates a

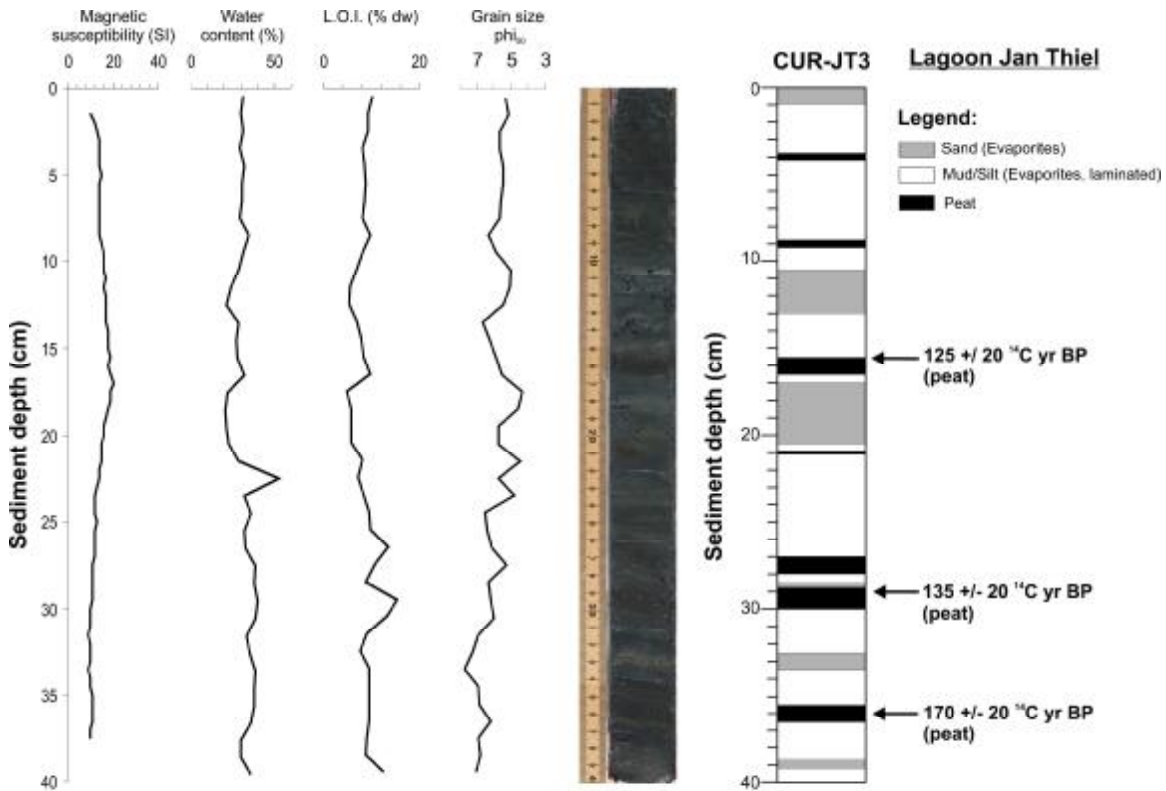
**Figure 2-6:** Core photo and schematic profiles of core JT3 (Lagoon Jan Thiel).

This core was taken from a more inland location on the southeastern shore of Lagoon Jan Thiel (Fig. 2-1). The 40cm core is intensely laminated and has the same composition as JT1 and JT2 (Fig. 2-6). It is mainly composed of evaporates of varying grain sizes and is intercalated by several peat layers. The evaporite layers represent drier conditions while the peat layers indicate freshwater input. There was no substantial evidence to suggest tsunami or hurricane events in this location. No distinguishable microfossils were seen in thin section. Three AMS dates on peat reveal a deposition in recent times (Table 2-4).

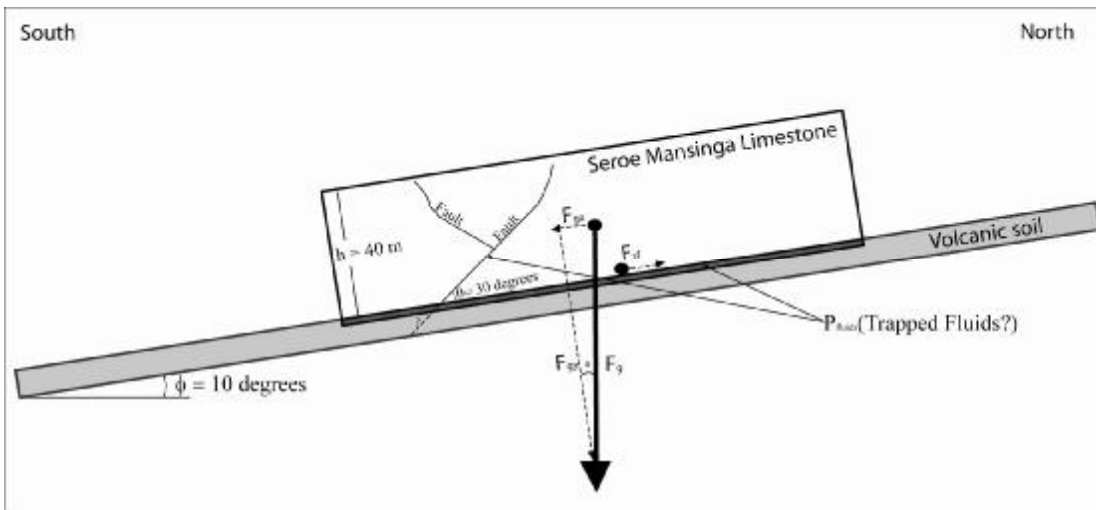
**Figure 3-1:** Free-body diagram of the Seroe Mansinga formation on volcanic soil incorporating gravitational, frictional, and possible fluid forces. Buoyant forces are neglected in this scenario.

$$F_{\text{failure}} = F_{\text{sf}} - F_{\text{gx}} = \mu (Mg \cos(\phi) - F_{\text{fluid}}) - Mg \sin(\phi) \quad (1)$$

$$S_{\text{failure}} = S_{\text{sf}} - S_{\text{gx}} = \mu (\rho h g \cos(\phi) - P_{\text{fluid}}) - \rho h g \sin(\phi) \quad (2)$$

Where  $S_{\text{failure}}$  is the stress required for failure;  $S_{\text{sf}}$  is the static friction stress;  $S_{\text{gx}}$  is the down-slope gravitational stress,  $\rho$  is the rock density (2000 kg/m<sup>3</sup>),  $h$  is the thickness of the limestone (40 m), and  $P_{\text{fluid}}$  is the fluid pressure.
